HIGH-SPEED PHOTOGRAPHS OF A YR-4B PRODUCTION ROTOR

BLADE FOR SIMULATED FLIGHT CONDITIONS IN THE

LANGLEY FULL-SCALE TUNNEL

By Richard C. Dingeldein and Raymond F. Schaefer

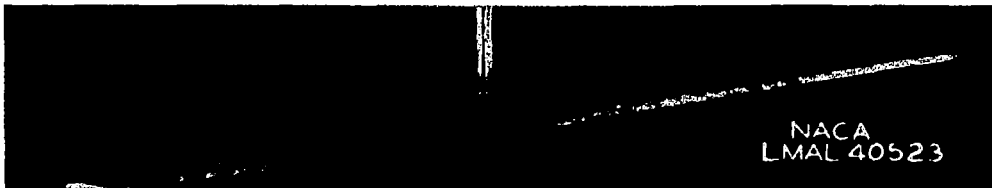
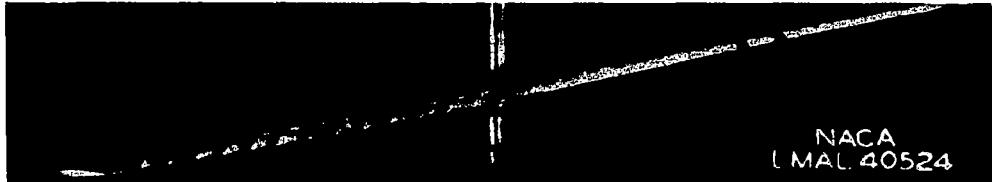
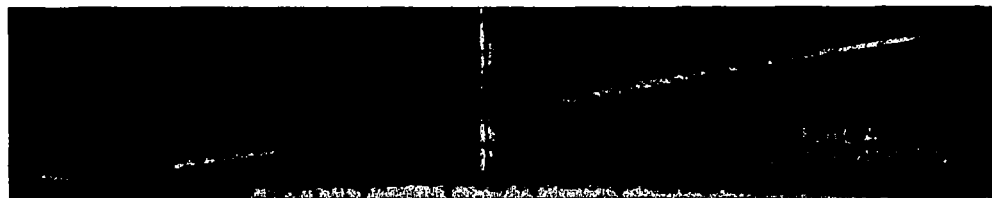
Figure 5.- High-speed photographs of a YR-4B production rotor blade in simulated flight conditions, ψ , 0° .

The test conditions for which the blade pictures were obtained are listed in table I. The high-speed photographs of a rotor blade taken in the plane of rotation for the four test conditions are presented in figures 5 through 10 for the six azimuth angles. The pictures taken for condition 1 by the overhead camera for these azimuth positions are shown in figure 11. The actual azimuth angles corresponding to 0° , 45° , 135° , 180° , 225° , and 315° are shown to be 0° , 47° , 131° , 181° , 223° , and 308° and are expected to be approximately the same for conditions 2, 3, and 4, inasmuch as the blades were photographed at the same rotor-shaft cam setting for all four conditions.

The photographs of figures 5 through 10 show the type of surface deformation that occurs on a fabric-covered rotor blade. Because of the nature of the external pressures which produce rotor-blade lift, internal pressures below free-stream static pressure will exist somewhat outboard of the point at which fabric sagging appears on the upper blade surface. Similarly, internal pressures greater than free-stream static pressure will exist somewhat inboard of the point at which fabric bulging is shown on the lower surface. The spanwise distribution of internal pressure has been roughly estimated from the photographs, which indicate that the internal pressure from the root to approximately the 77-percent radius (25th rib) is below free-stream static pressure. The fabric bulging on the lower surface is difficult to detect from the photographs; however, the internal pressures for approximately the outboard 10 percent of the radius appear to be greater than free-stream static pressure. Calculations prove that the difference in internal pressure between the blade root and the tip, assuming no intermediate venting, will be equal to the dynamic pressure at the tip. This amounts to approximately $3\frac{1}{4}$ inches of water in the present case. The results of the tests of rotor-blade sections in two-dimensional flow published in reference 2 indicate that the bulged portions of the blade will probably cause an increase in section drag coefficient, a decrease in maximum section lift coefficient, and a forward movement of the aerodynamic center. The effect of fabric sagging is indicated by the same

In almost all of the high-speed photographs the rotor blade droops distinctly near the tip. This effect may be the result of a loss of lift at the blade tip, together with the predominance of the centrifugal force at this point. It is not believed to be the result of inertia loads occurring during flapping since only a small part of the droop appears to be periodic.

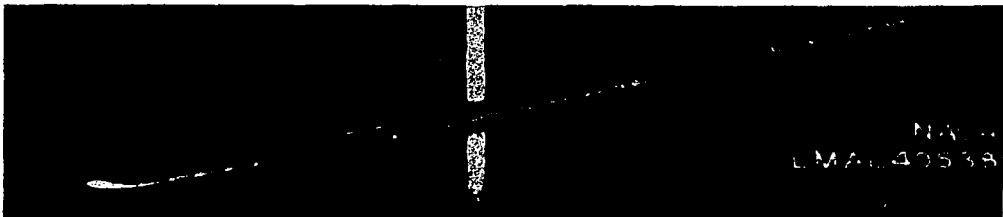
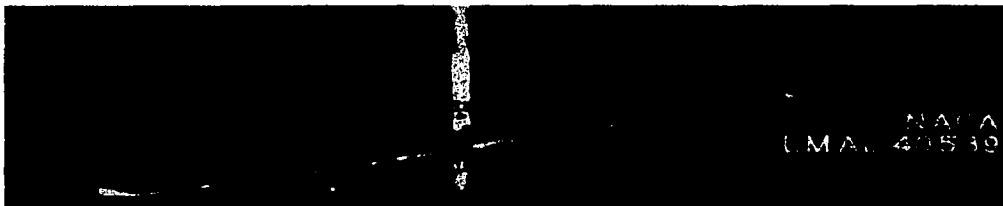
Figure 8.- High-speed photographs of a YR-4B production rotor blade in simulated flight conditions. ψ , 180° .
